Care & Maintenance Instructions ■

Altus® Seating

August 2012

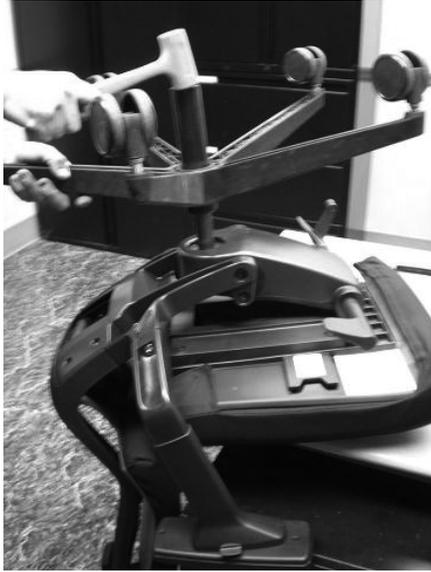
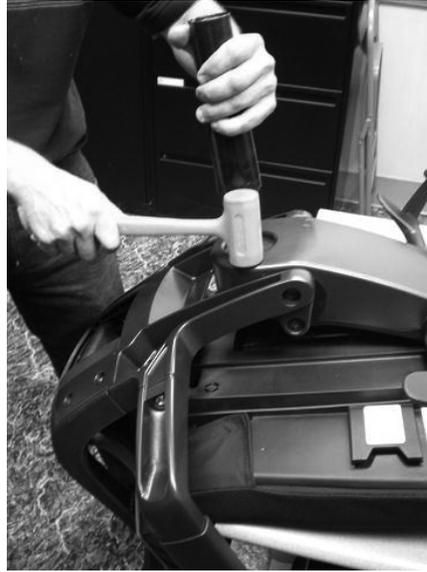
Figure 1

1. Disassemble the base from the cylinder by pulling up on the base and tapping on the bottom of the cylinder with a rubber or plastic mallet (to prevent marring of the painted surfaces) (Figure 1 & 2).

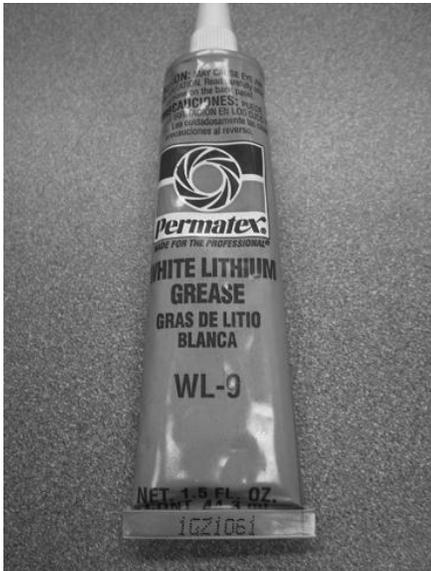
Figure 3

2. The tapered surface of the cylinder socket in the chair control shows an irregular surface (Figure 4).
3. Apply a coating of white lithium grease (Figure 3) to the machined surface of the cylinder socket, being careful not to allow excess grease to get on other painted portions of the chair (Figure 4).

Lubricate the tapered surface of the cylinder socket with white, lithium grease.

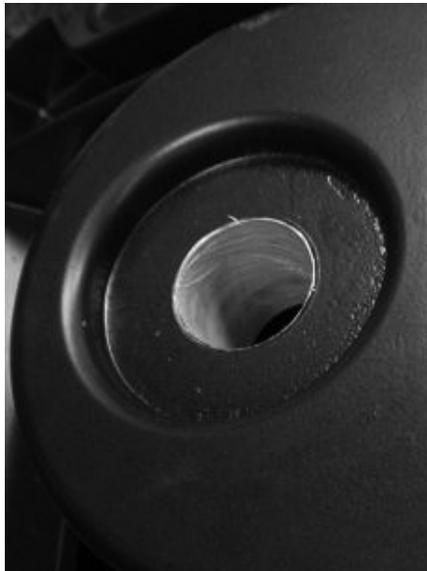
Figure 4

When rocking, sitting down on the front half of the seat, or just moving around in the seat the chair makes a low pitched sound that has been described as both “creaking” and “squeeking.” The root cause is an irregular surface on the cylinder socket portion of the chair control. Movement causes the noise to be generated by the micro-movement between the cylinder shaft’s tapered end and the surface of the tapered hole in the chair control.
